INTERIM REPORT

**B-58 AIRCRAFT AVIONIC SUBSYSTEMS
RELIABILITY AND MAINTAINABILITY
IMPROVEMENT PROGRAM**

June 1965

ARINC RESEARCH CORPORATION

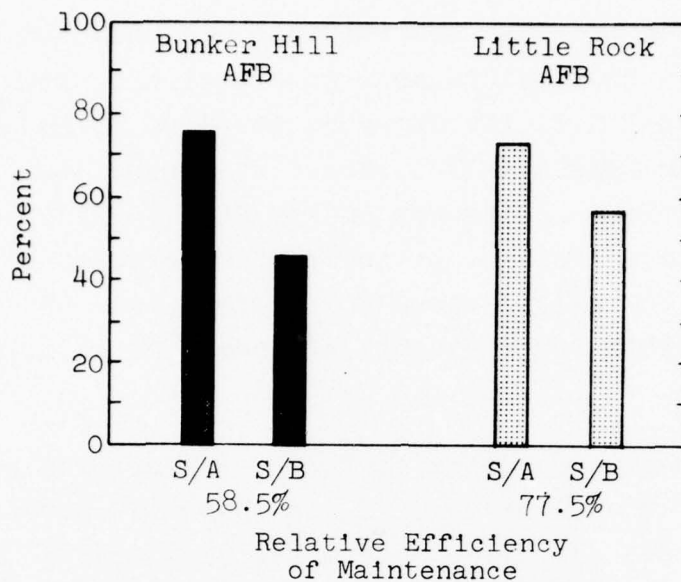
The results of these observations are shown in Figure 3-3, which indicates that maintenance personnel are often unable to restore the APN-113 to its expected level of flight reliability following an in-flight malfunction. It further indicates a substantial difference between Bunker Hill and Little Rock AFB's in the relative efficiency of their first attempt to repair a malfunction. Following successful flights, the APN-113's at both bases exhibit nearly identical levels of in-flight reliability.

FIGURE 3-3
DOPPLER "NEXT-FLIGHT SUCCESS" ESTIMATES

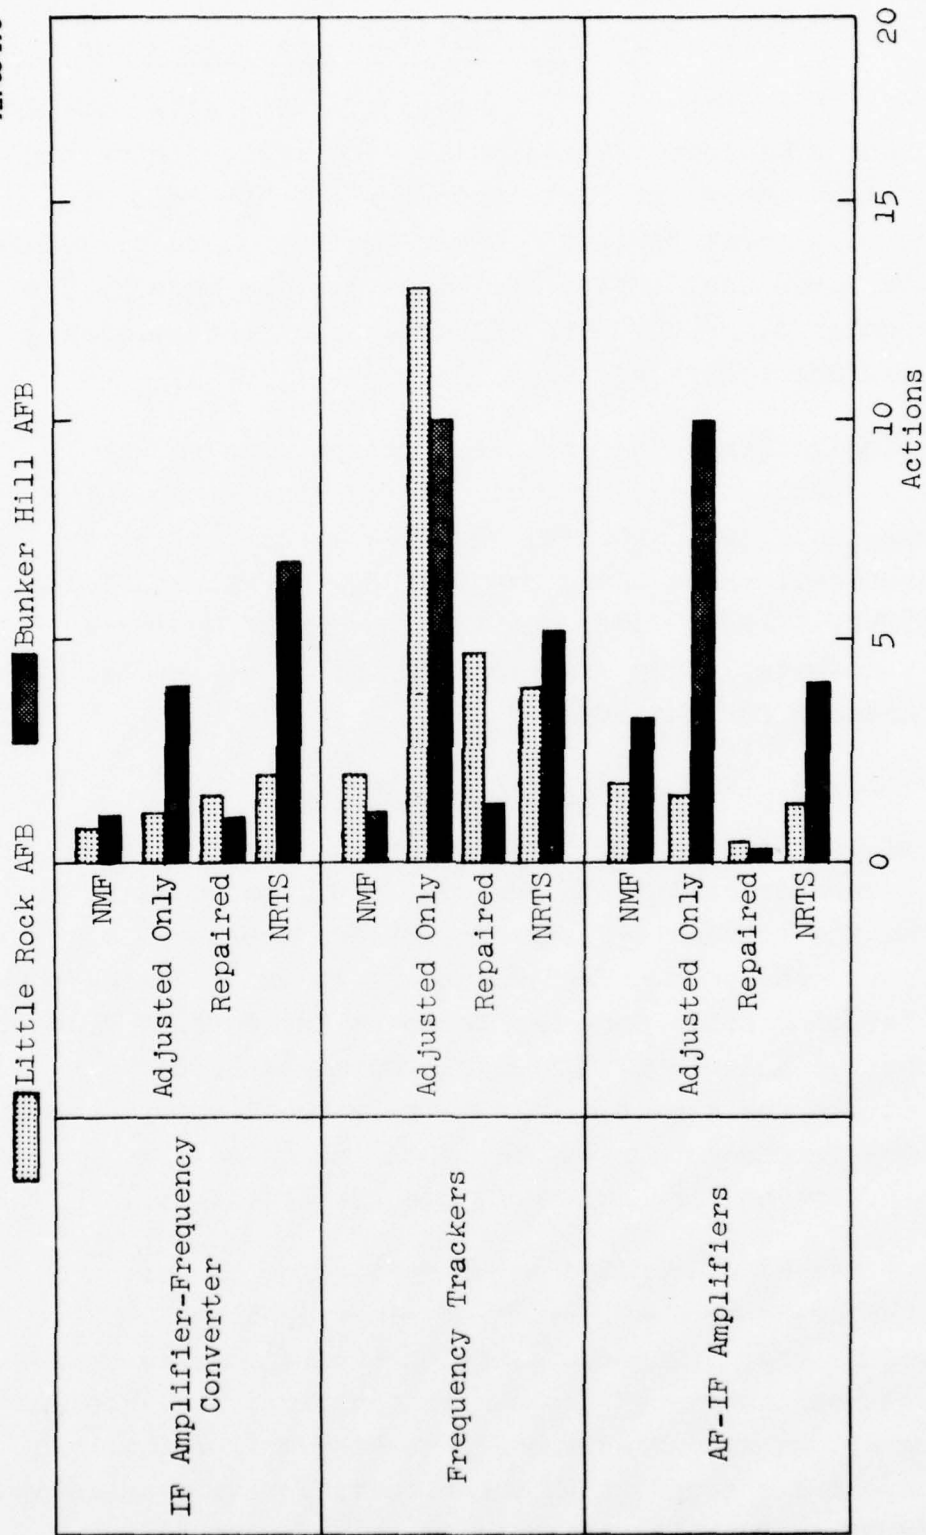
Representative LRU actions per 1000 flight hours are shown on Figure 3-8. PSDP actions related to receiver and frequency tracking loop functions are shown on Figure 3-7.

FIGURE 3-8
RECEIVER LOOP FUNCTION - DISTRIBUTION OF LRU
ACTIONS PER 1000 FLIGHT HOURS

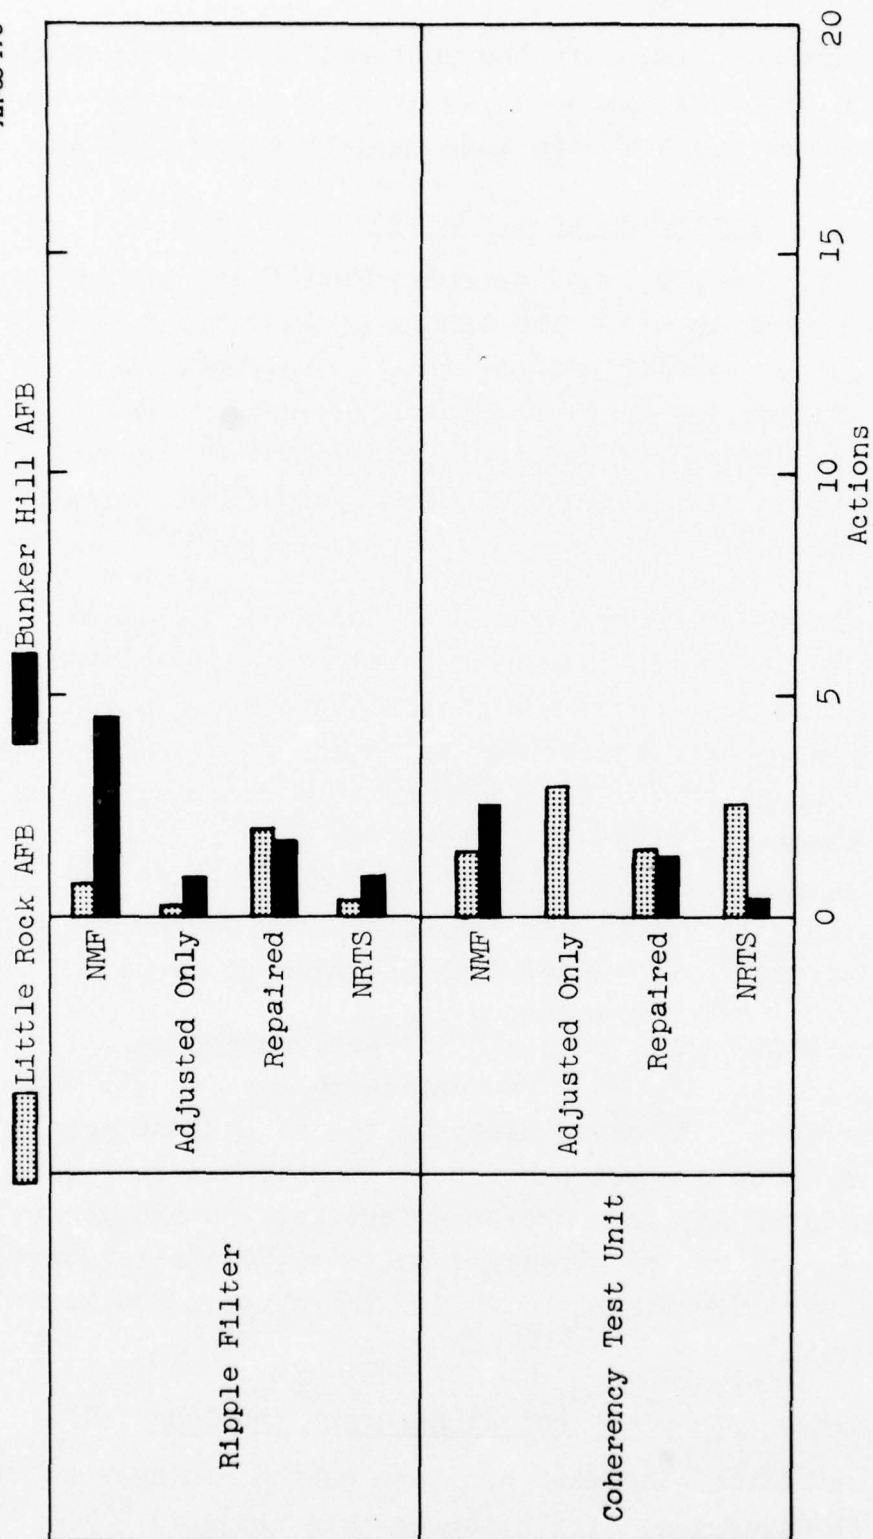
Basically, one LRU, the Coherency Test Unit, evaluates all APN-113 LRU's when in use. The coherency test may be performed in-flight by the operator when an APN-113 malfunction is suspected. During the test, a special 200-cycle modulation of the APN-113 transmitter determines the quality of the APN-113 lock. Relative distribution of Coherency Test Unit repair actions is indicated in Figure 3-10.

Three APN-113 LRU's have general application to all APN-113 functions. The PSDP LRU may be related to all the various functions. Relative distribution of actions per 1000 flight hours pertaining to the functions is shown in Figure 3-7. The Ripple Filter LRU and Coherency Test Set LRU are generally applicable to all of the APN-113 functions. Distribution of LRU actions per 1000 flight hours for these two LRU's is shown in Figure 3-10.

FIGURE 3-10
GENERAL SYSTEM FUNCTIONS - DISTRIBUTION OF LRU ACTIONS
PER 1000 FLIGHT HOURS

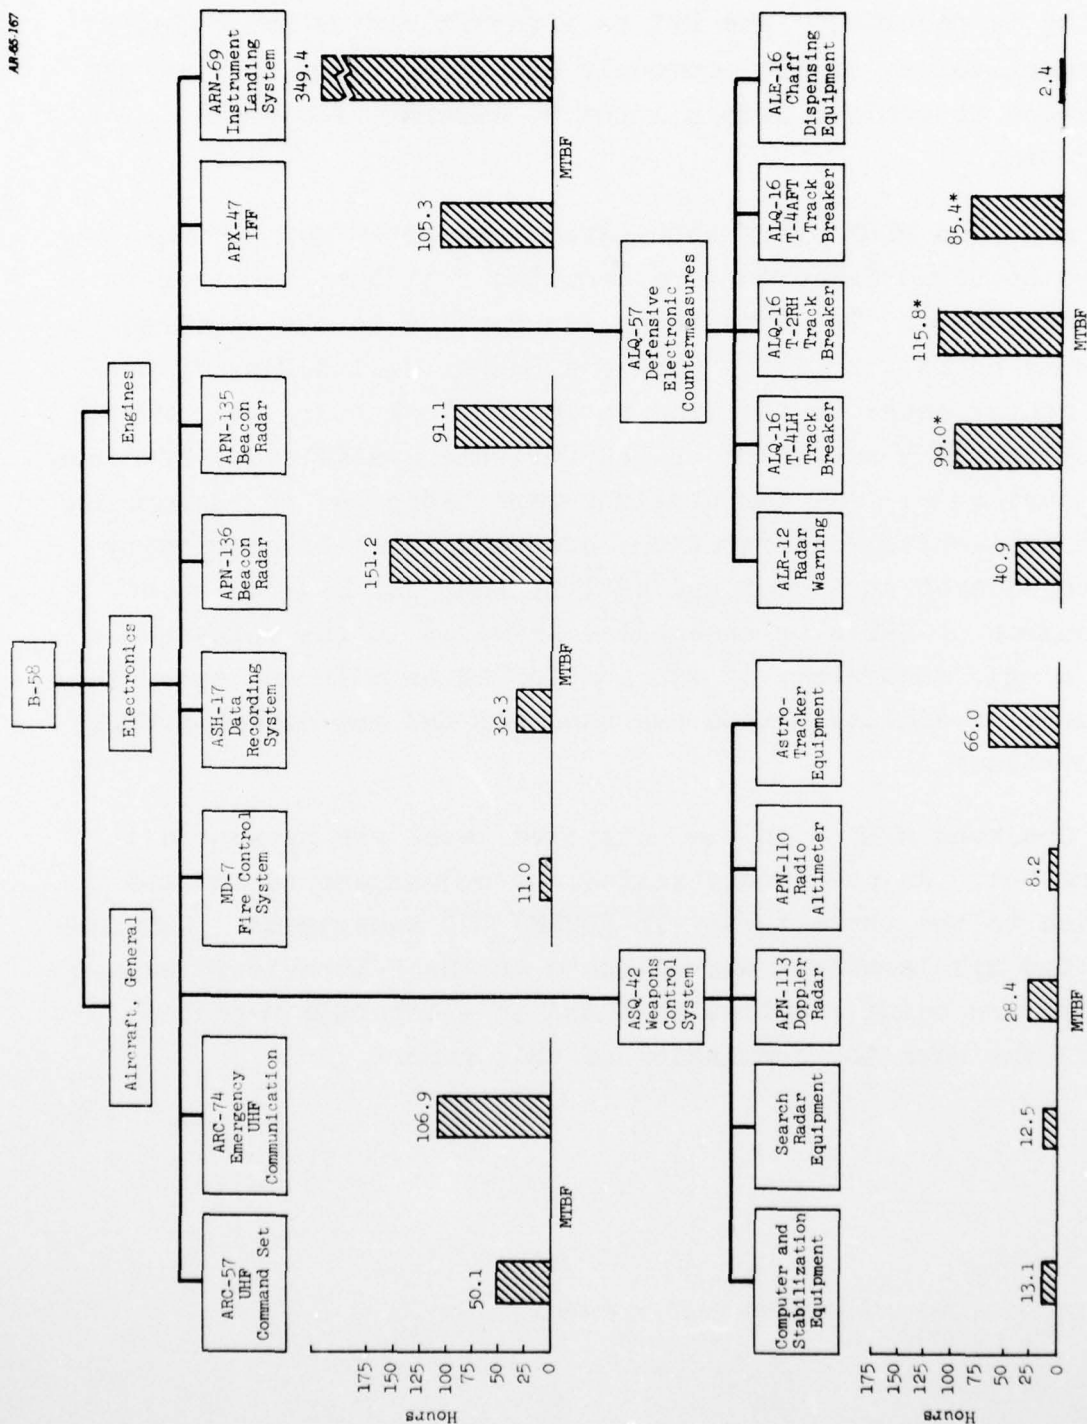
Observed MTBF's at the subsystem level are presented in Figure C-1. As previously stated, no adjustment factor was applied to the three AN/ALQ-16 (DECM) "T" subsystems. Complete data for all levels of surveillance on the B-58 avionic subsystems are being supplied to WRAMA as a separate report coincident with the submission of this report.

FIGURE C-1
CURRENT F-58 OBSERVED AVIONIC SYSTEM AND SUBSYSTEM MTBF'S
